**GREENING PUBLIC INFRASTRUCTURE - PROMOTION  
OF ENERGY-EFFICIENCY AND UPGRADE OF HYDRO  
POWER PLANT PERUĆICA - INSTALLATION OF UNIT U8  
Consultancy Services for Upgrade of Hydro Power Plant  
Perućica  
Installation of Unit U8**

**SECTION D  
ACCOMPANYING REPORTS  
BOOK 3: ENVIRONMENTAL AND SOCIAL IMPACT  
ASSESSMENT (ESIA)**

**22024-D-03**

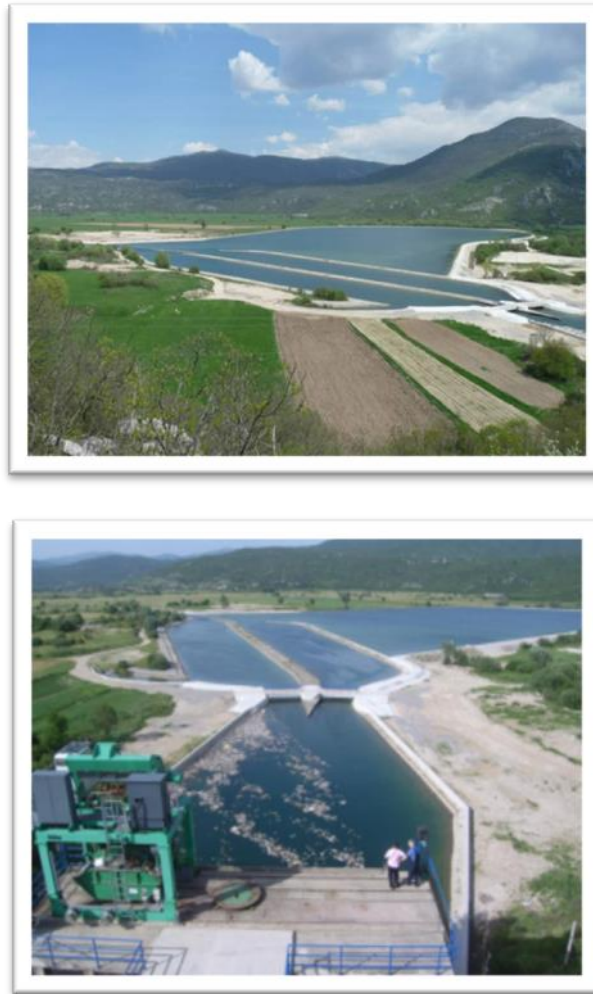
**Figure 3: Retention basin**

Access to the retention basin is possible via the existing access road Podgorica - Nikšić. The road is in good condition and can be used. Access is possible right next to the settling tank, channel and retention basin.

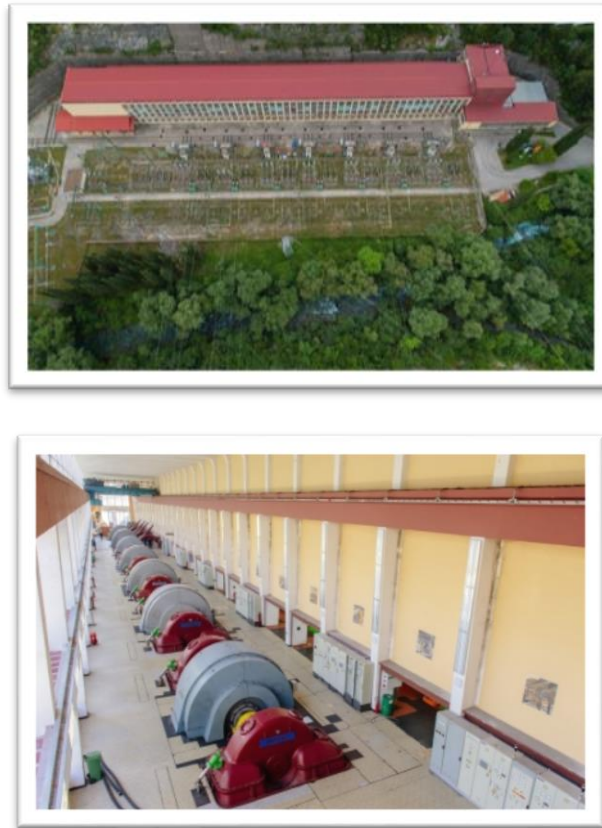
**Figure 4: Machine building**

In the machine building of HPP "Perucica", seven twin turbine-type "Pelton" generators with the horizontal properties of the total installed capacity of 307MW were built. Five units have installed capacity of 40MVA and two of 65MVA. It is planned that the eighth power generator of 65MVA to be installed.

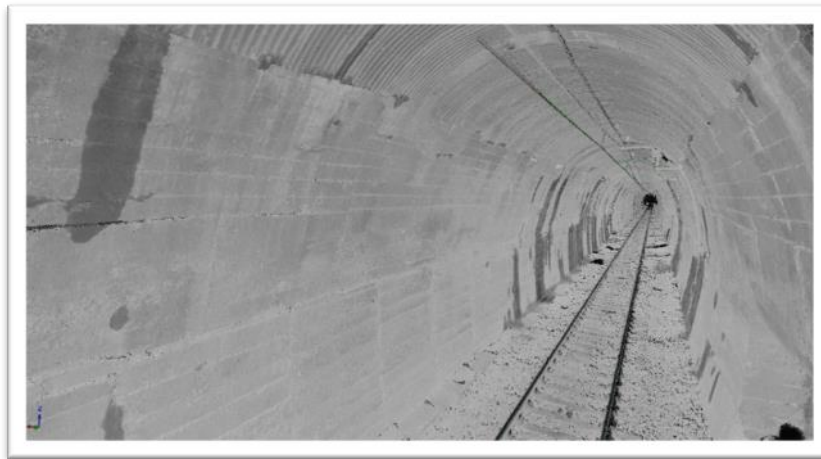
**Figure 5: An example of tunnel scanning**

The tailrace tunnel is in good condition, except for the last 20 m before the tunnel exit, and its transition to the canal part of the tailrace. The imagery of the damage on the concrete structure shall be the most important input data for a part of the Main Design for rehabilitation of canal and tailrace tunnel, which shall deal with reparation of damages within the tunnel.

Before the start of surveying the condition of the tunnel and mapping, a system for marking the damage at the site will be adopted, according to the types and dimensions of damage. Spray paint shall be used, which can be applied on a wet surface, in shades that are well visible in dimly lit areas. Simultaneously with the marking of the damage, the tunnel chainage shall be measured and marked.

After the damage has been marked, scanning will be performed by means of high precision geodetic laser scanning. Based on the obtained image, a plan of recorded tunnel damages will be prepared, which will be further used for the purpose of designing rehabilitation works.

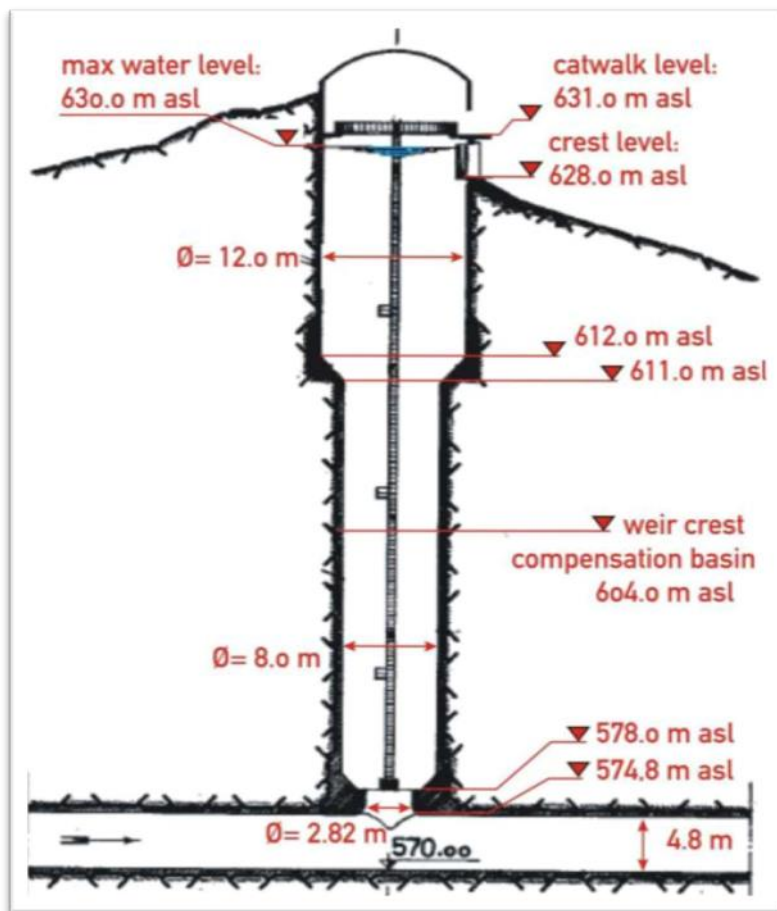
**Figure 7: Surge tank with dimensions**

The reservoir is located in Slivlje and the entire reservoir is concreted. The surge tank exhibits a total depth of 60 metres from the highest water level that its design allows for (630 m asl) to the invert of the headrace tunnel. The diameter of the shaft increases over the height from 8 to 12 metres (Figure 7).

Elimination of the remaining quantities of water from the level above 628 m asl in the surge tank through removal of the surge tank top does not cause hydraulic issues, while spilling of water will result in unexpected instantaneous flooding. Therefore, it is necessary to analyse the structure of the upper chamber where the remaining water is collected and returned to the surge tank, by monitoring the decrease of the water level in the surge tank.

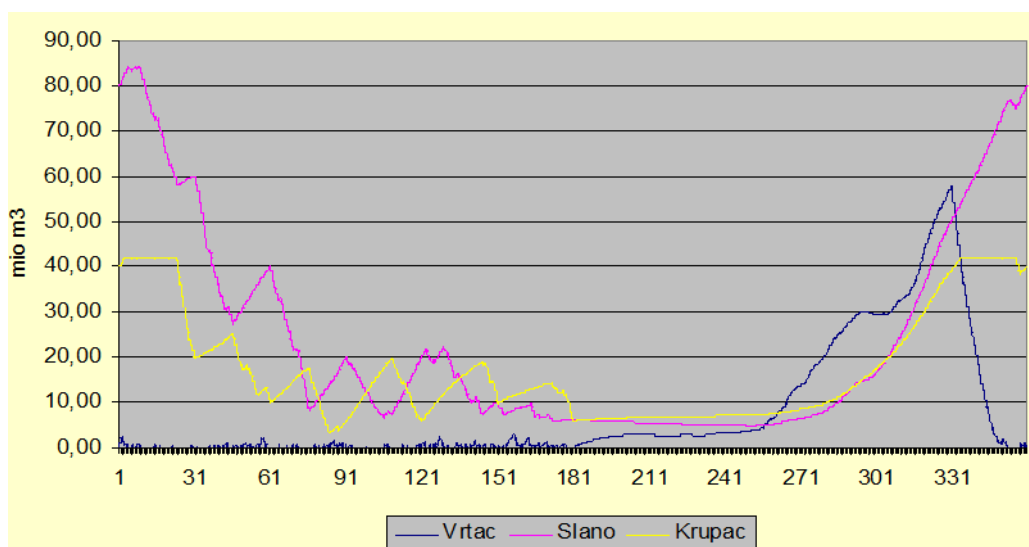
**Figure 8: Accumulations condition in case “no project” alternative**

The condition of the pool as well as losses without the realization of the project, i.e. the installation of the 8th unit is shown in the following figures.

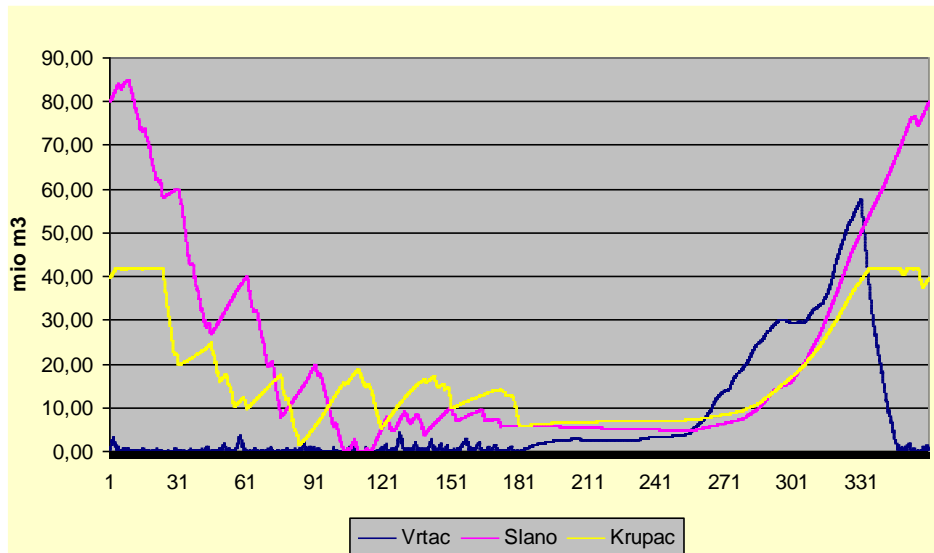
**Figure 10: Condition of the accumulations in case of installation of the 8th Unit**

In the scenario with included investment, which will include reconstruction and modernization measures, HPP Perucica produces an average of 1,053GWh per year. Of the total annual production, 1-5 units account for 533GWh, which is 51%, 6-7 units for 345GWh, which is 33%, and the eighth unit, 173GWh, which is 16% of the total production. In the variant with the investment, the power plant generates revenue in the amount of EUR 84.5 million. The condition of the accumulations and the forecasted losses after the installation of the 8<sup>th</sup> unit are shown in the following figures

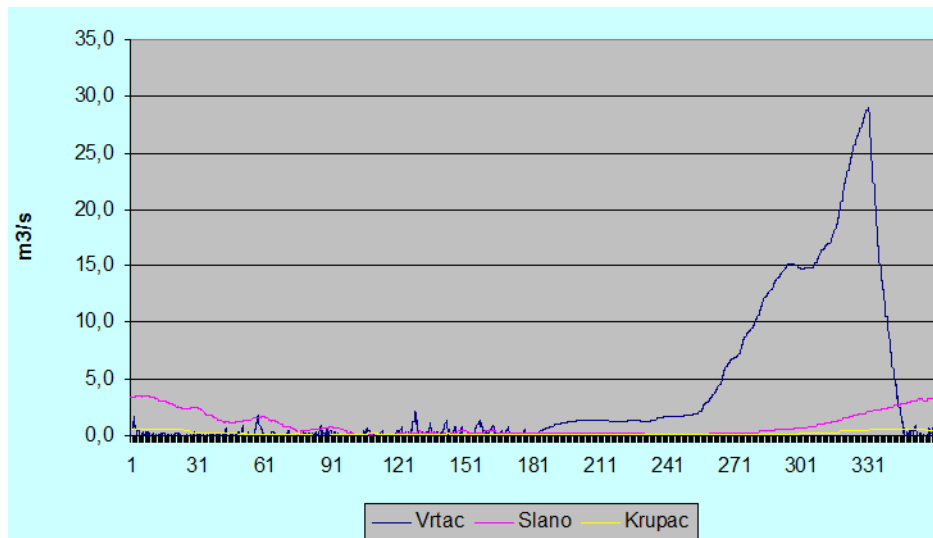
**Figure 11 Losses in accumulations in case of installation of the 8th Unit**

According to the obtained results in Feasibility study for the installation of the 8<sup>th</sup> unit in HPP Perucica, reconstruction of the existing drainage channel for Unit 8 and reconstruction of the Zeta I canal - retention basin is recommended and due to reduce losses which, due to water

infiltration occur at the location of the existing accumulations and thus increase the efficiency of the new unit.

According to the above, it can be concluded that due to the installation of the 8th unit will achieve improvement of operating conditions of the power plant (increase in production) is achieved by installing the eighth unit. The production of HPP Perucica will increase by 7.41GWh per year in average.

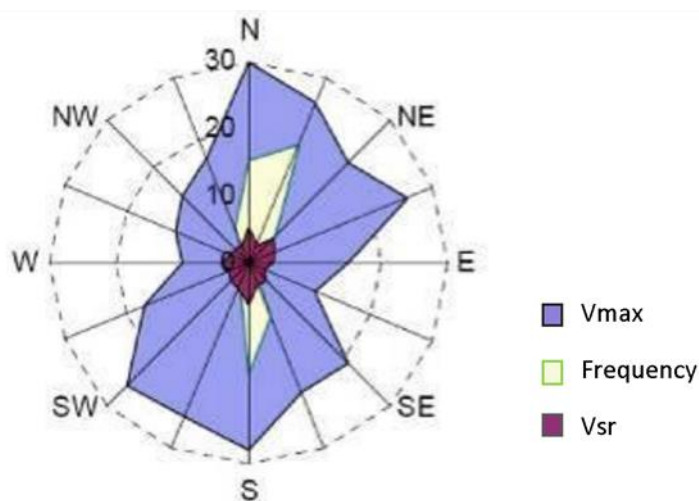
**Figure 14: The wind rose for Nikšić**

Nikšić has strong north-south winds. Anticyclonic, rarely cyclonic wind, which usually lowers the temperature, reduces cloudy and humidity, usually blows from the north or northeast direction over the mountains and especially over the Javorak, Planinica, Stitovo passes. The south wind is also quite strong, especially in the Nikšić field. As a result of the relief, the mountains Orjen and Bijela gora, as well as the mountains who are located inside of the Nikšić field sometimes when the south wind blows (through the inner slopes of the mountains in the fields, Nudo valley and the other valleys) there is an increase in temperature, melting snow and occurrence of floods. In the area of the municipality of Nikšić, especially in the western parts closer to the sea, there is a wind mistral, wet and rainy wind.<sup>4</sup>

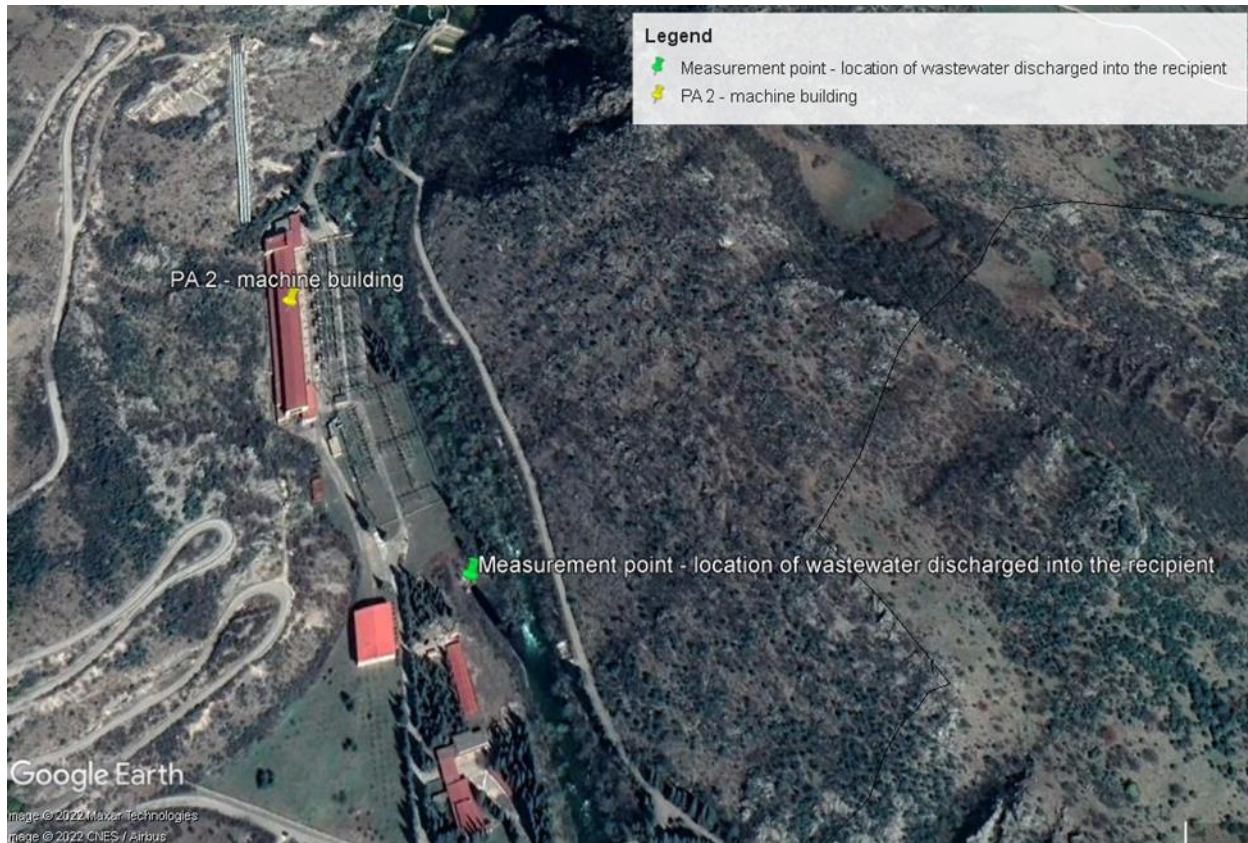
**Figure 18: Measuring point for wastewater monitoring**

Also, EPCG is engaging accredited laboratory the Centre for Ecotoxicological Research Montenegro (CETI) to perform physical and chemical analysis of waste waters, which is generated by the work of HPP Perucica. Sampling was performed at the site of wastewater discharged into the recipient (*Figure 18*).

During 2020, 4 cycles (May, June, September, December) of sampling waste water were performed at location shown above. Physic-chemical analysis of wastewater showed that the examined parameters in the wastewater sample correspond to the conditions for wastewater discharge into the recipient – in accordance with *Rulebook on quality and sanitary-technical conditions for discharge of wastewater into the recipient and public sewerage, manner and procedure of testing the quality of wastewater, minimum number of tests and content of the report on the determined quality of wastewater* ("Official Gazette of Montenegro", No. 45/08 of 31 July 2008, 9/10 of 19 February 2010, 26/12, dated 24 May 2012, 52/12, dated 12 October 2012 I 59/13, of 26 December 2013). Microbiological tests of wastewater were also performed, where the results showed that no microorganisms were present in the tested water.
